REPORT NAEC-92-131

**AEROSTRUCTURE NONDESTRUCTIVE EVALUATION
BY THERMAL FIELD TECHNIQUES**

Final Report for Period 17 March 1978 - 17 January 1979
AIRTASK A3400000/051B/8F41461406

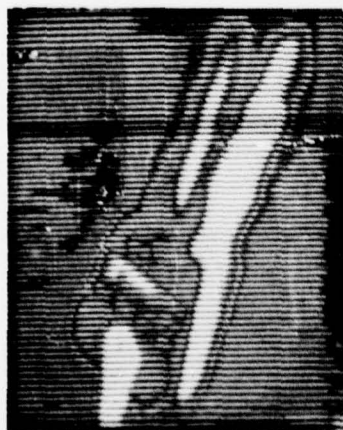
FINGER REFLECTION
WITH ISOTHERMS

FINGER REFLECTION
WITH GRAY SCALE

CAR KEY REFLECTION
WITH ISOTHERMS

CAR KEY REFLECTION
WITH GRAY SCALE

FIGURE 12 - HEAT REFLECTED FROM UNPAINTED SURFACE
OF 6061-T6 ALUMINUM SPECIMENS

3. Similar tests were conducted on Gr/Ep, B/Ep, and G1/Ep. No visible reflected heat was observed for these composites, even when surfaces were unpainted.
